SERVICE BULLETIN

Classification: EC97-026	Reference: NTB97-057	Date: September 15, 1997
-----------------------------	-------------------------	-----------------------------

1995-97 MAXIMA INTERMITTENT NO START

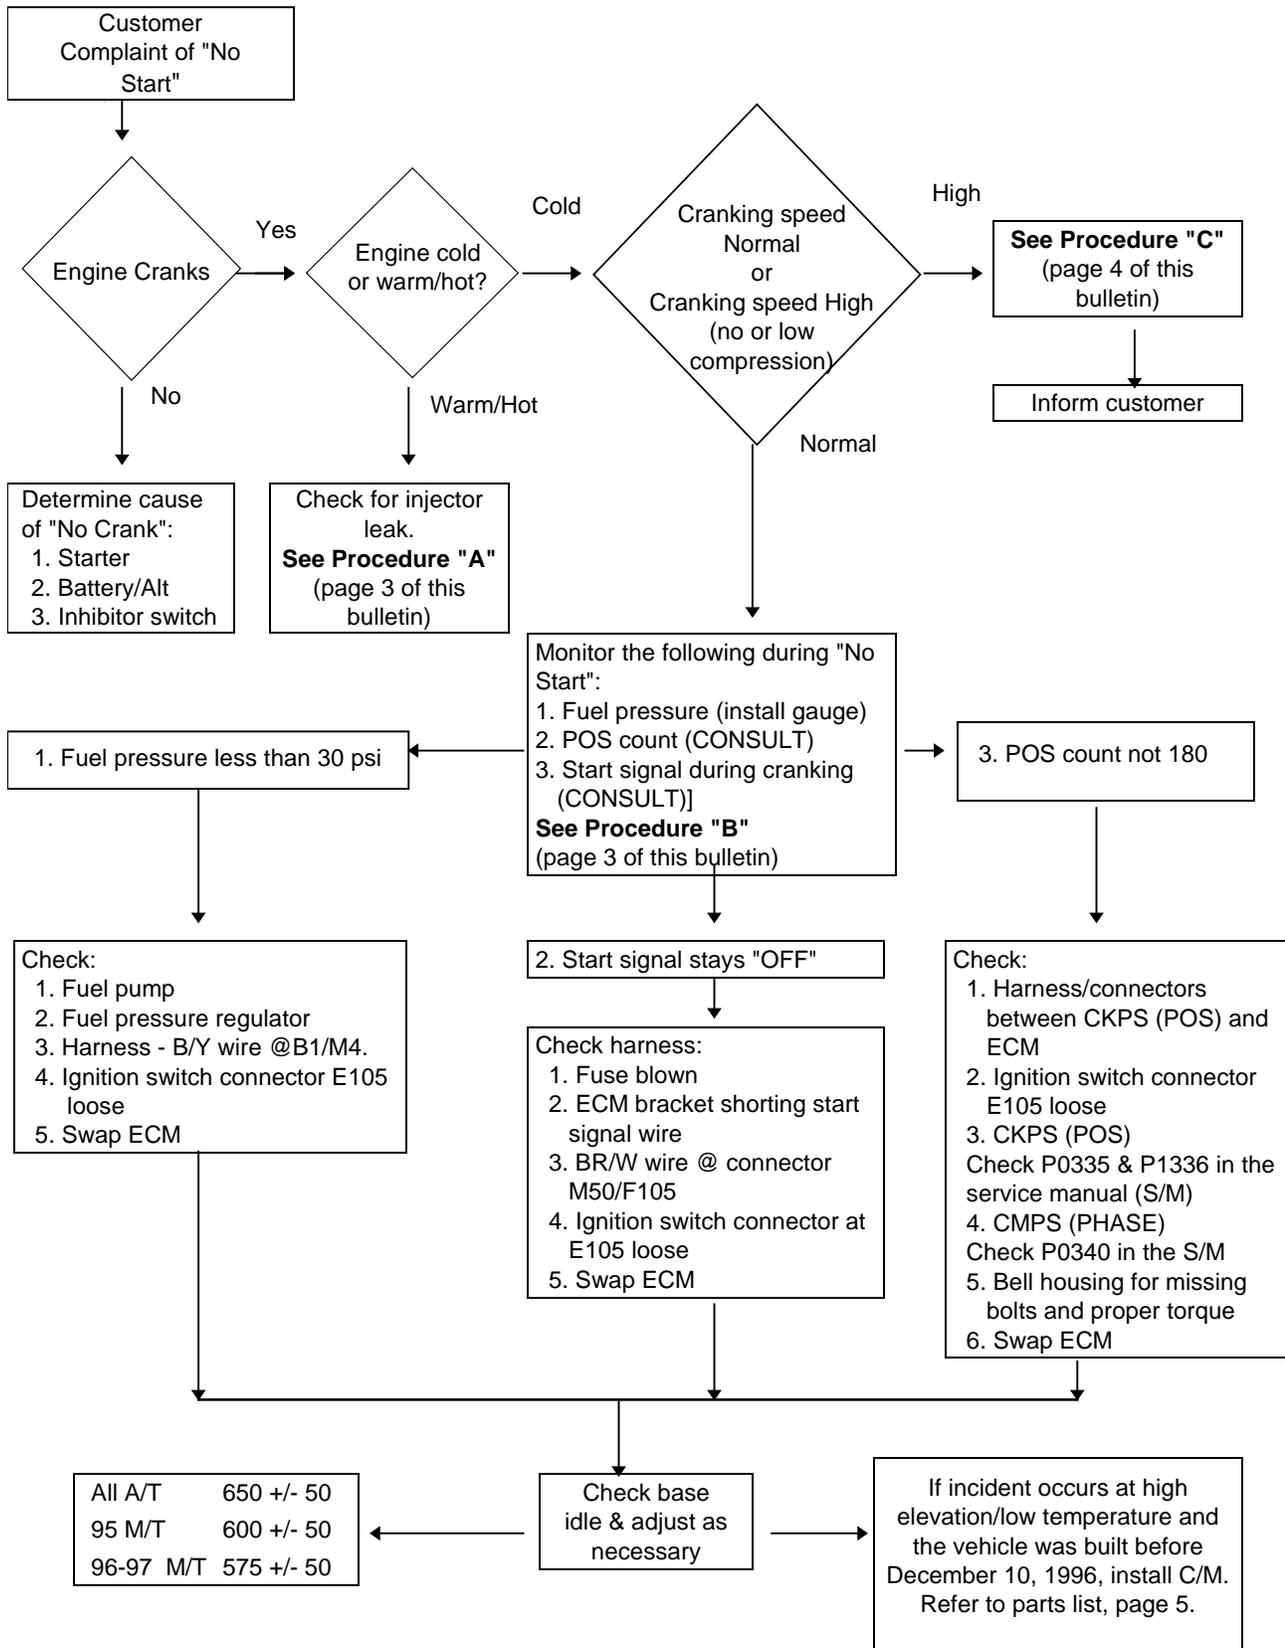
If a 1995-97 Maxima has difficulty starting after 2 to 4 hours cooling from operating temperature, or after an overnight cold soak at elevations above approximately 5,000 feet and ambient temperatures below approximately 40°F, the cause may be an over-rich fuel mixture during cranking. The engine will start after a long cranking period.

1. If you can verify the incident with the conditions listed above, follow the diagnostic flowchart on page 2 (cold engine, normal cranking speed).
2. Make sure the base idle is correct (see the flowchart).
3. Replace the engine control module (ECM) only if no other trouble is found. Use the chart on page 5 for the correct part number.
